Pinellas County Tornado and Downburst Wind Event

March 31, 2011

STORM DAMAGE ASSESSMENT

**A study of the installation of manufactured/mobile homes
and the effects of storm damage.**

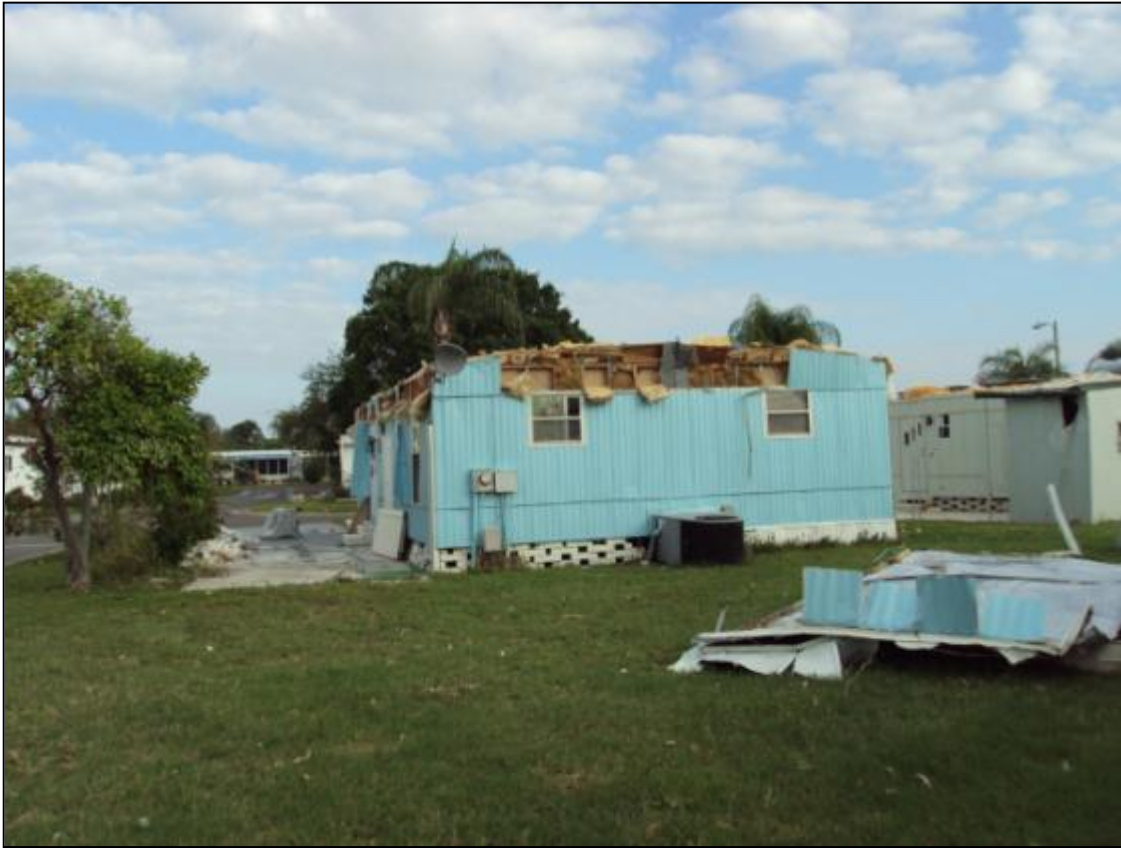
Carport blown away, taking the metal roof off also. The home did not move on its foundation.

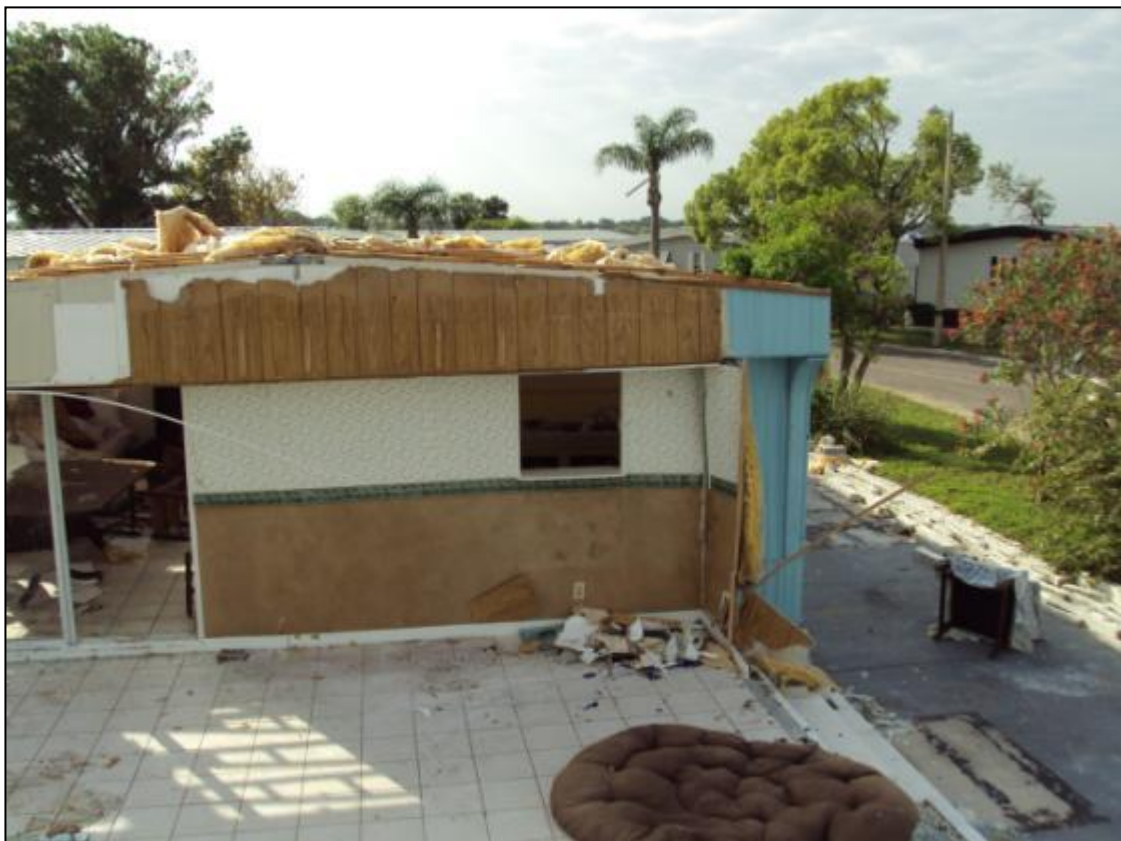
The home next door shows another example of a carport pulling the metal roof off the home.

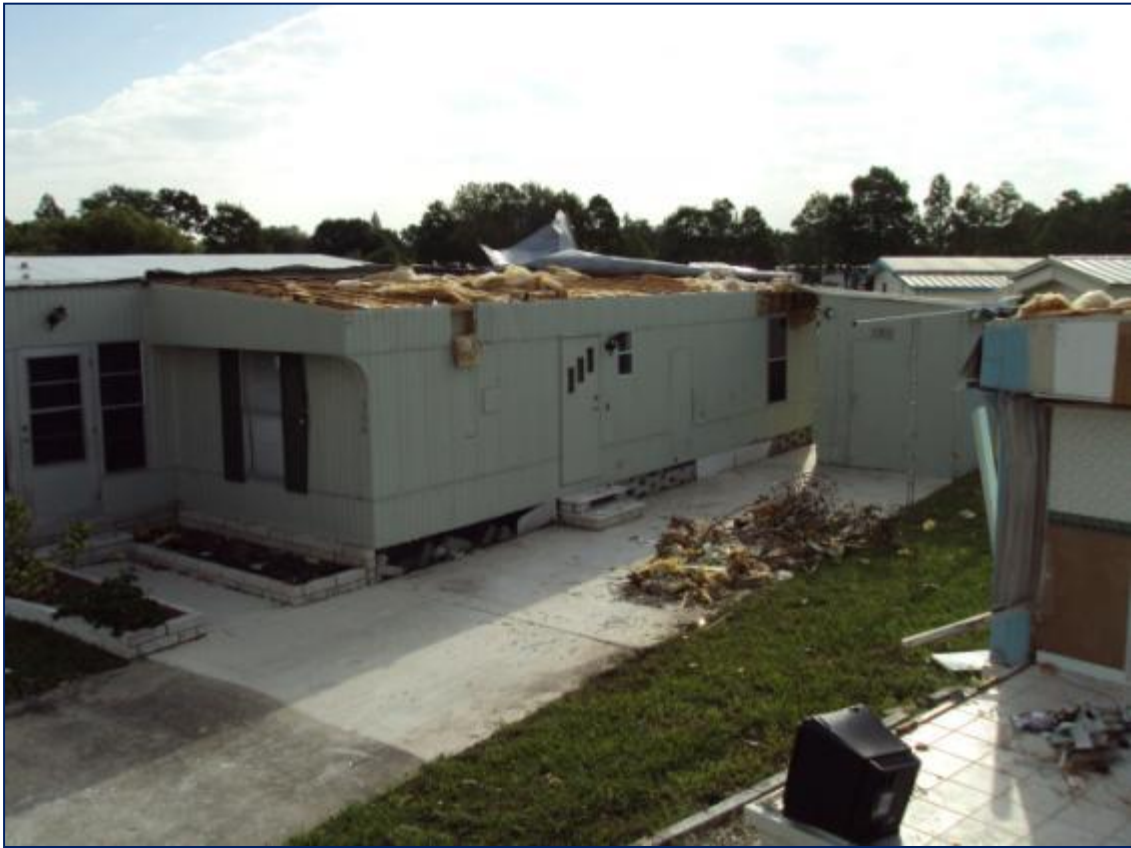
Same home, also missing the front addition which was added after the home was installed.

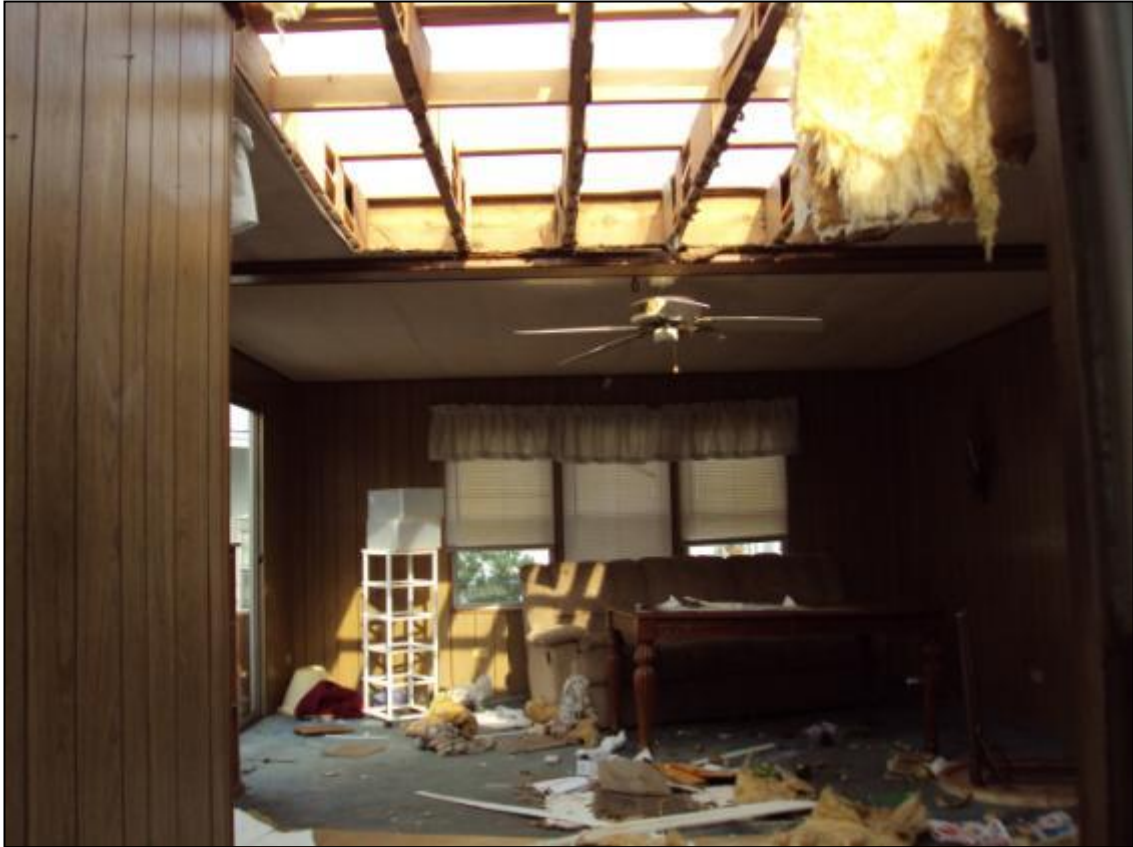
Once the metal roof of the home has pulled away, rain and wind usually make the home non-repairable even though the home stayed on its foundation.

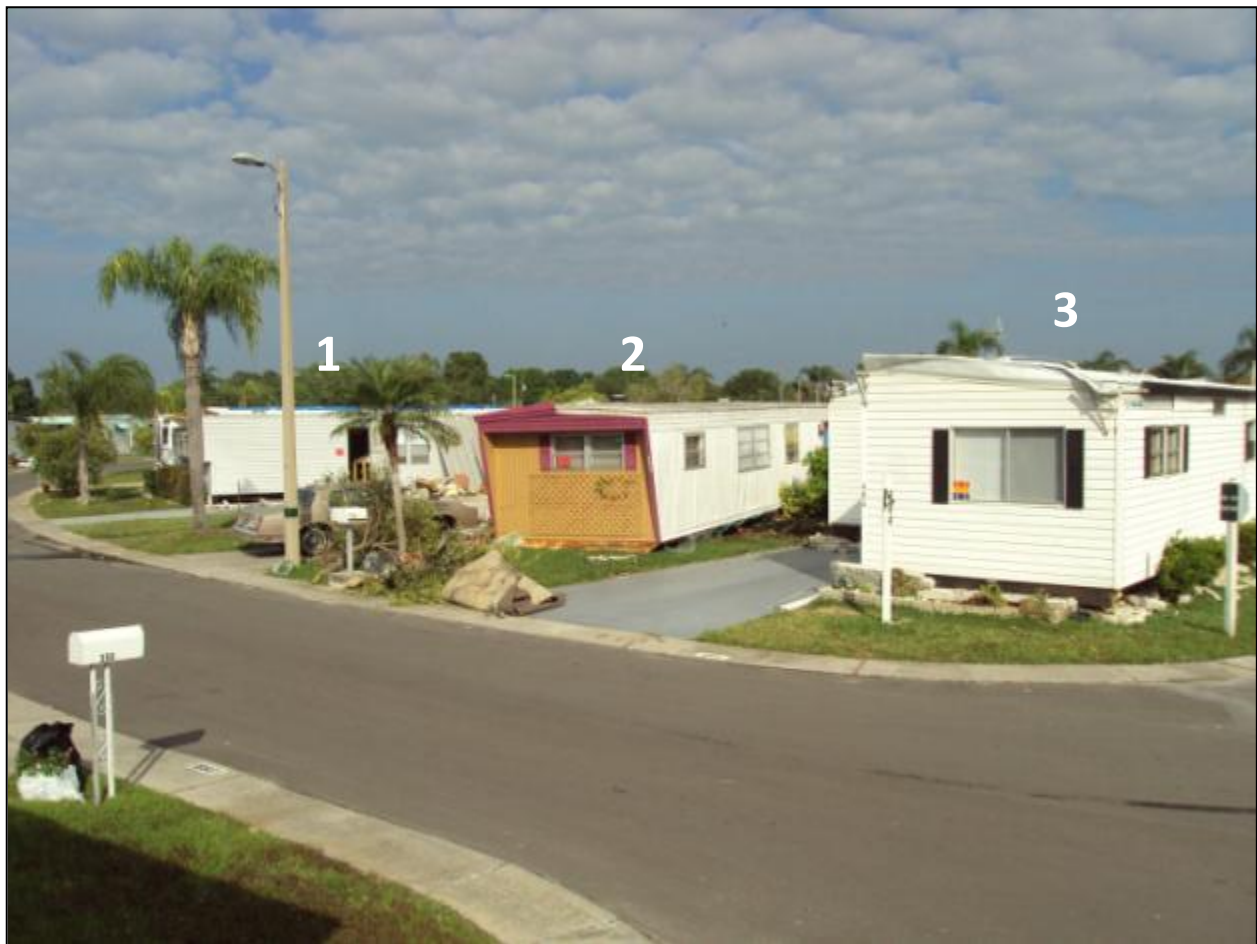
The Four Seasons Estates Community was retrofitted in January 2007. These three homes were the only three homes that moved on their foundations giving the appearance of a brief tornado touchdown. Home number one was retrofitted and moved 12 inches on its foundation. Home number three was retrofitted and moved 16 inches on its foundation. Home number two was not retrofitted and moved 25 feet on its foundation.

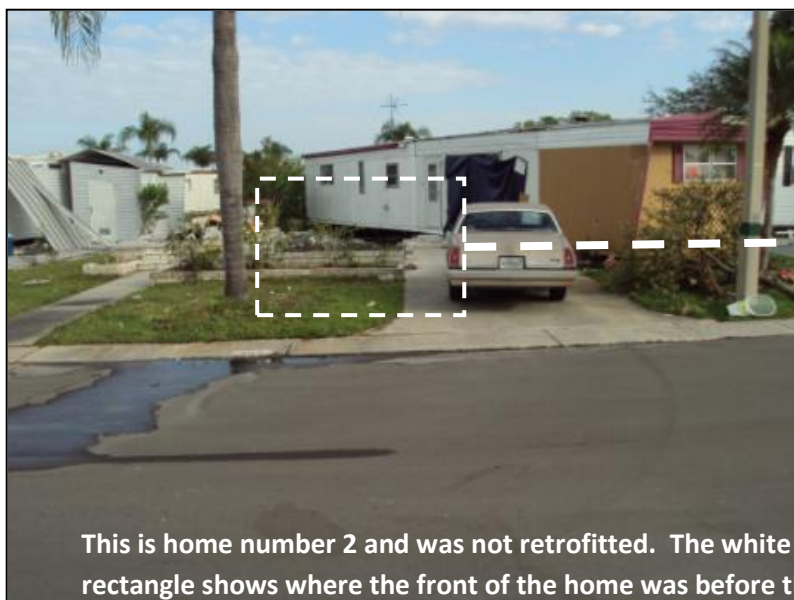
This is home number 2 and was not retrofitted. The white rectangle shows where the front of the home was before the

Rusted anchors.

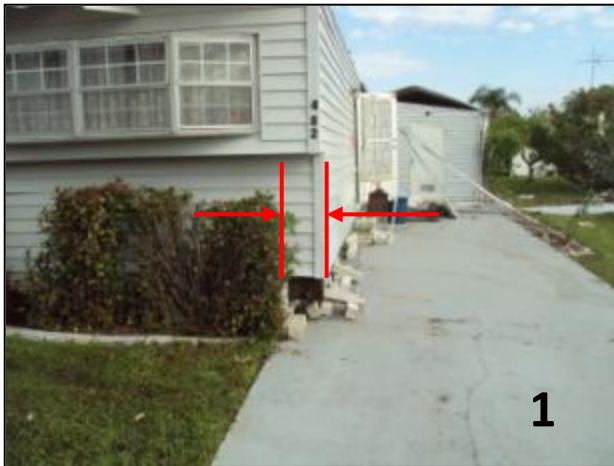
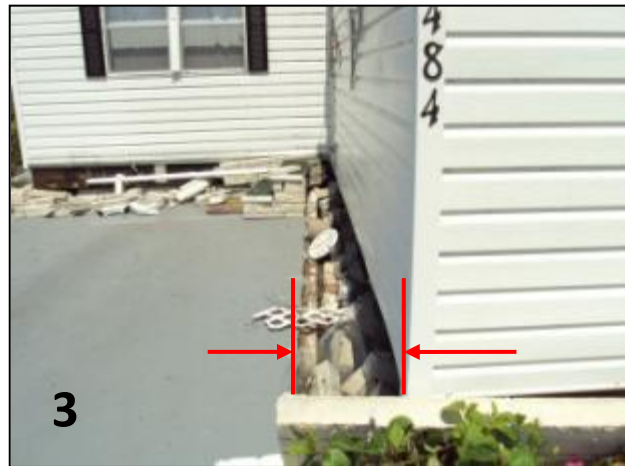
Home number one moved 12 inches on its foundation. Home number three moved 16 inches on its foundation.

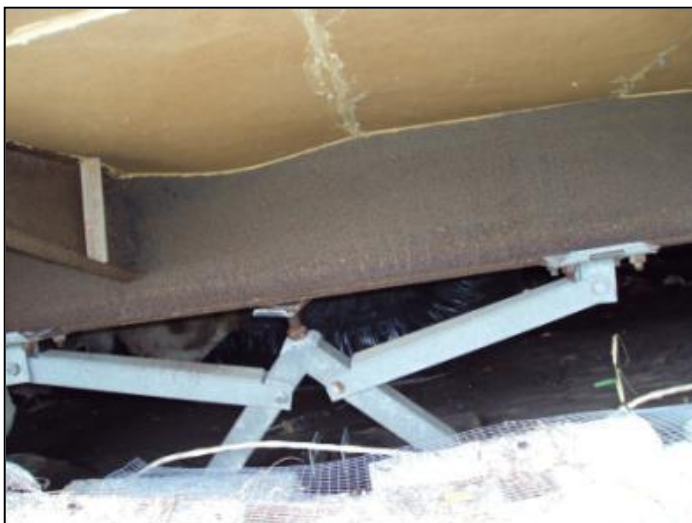
Longitudinal stabilizing devices added during the retrofitting process.

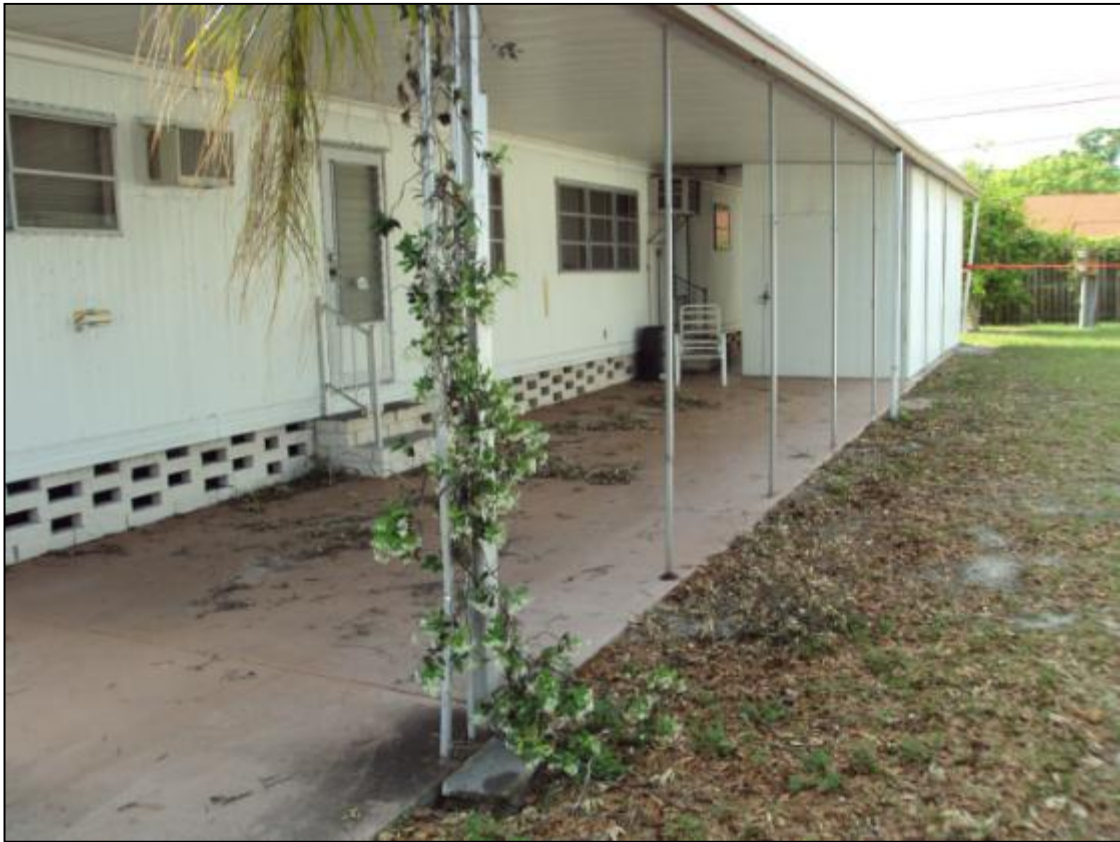
Old style carports will continue to be a problem during storms. The 1 ½ inch aluminum columns will not keep the carport in place during high winds.

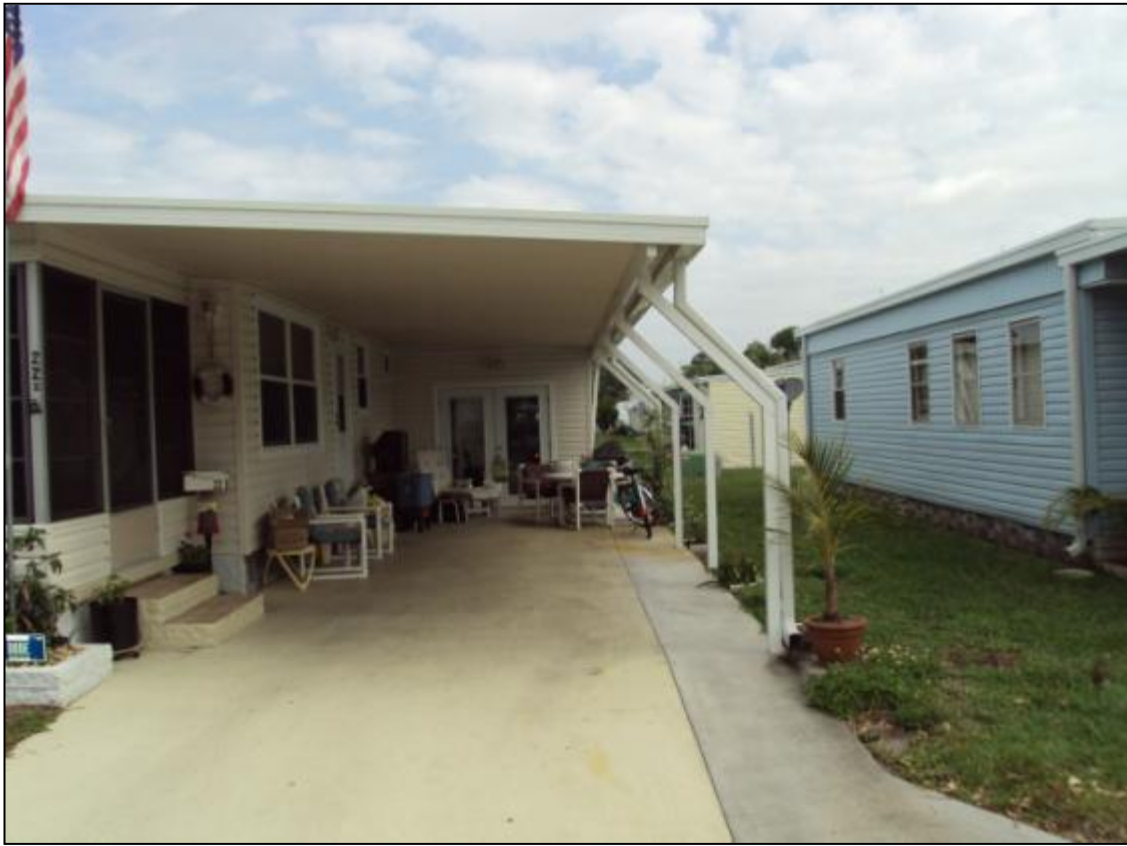
Some homeowners are modifying their column supports on their driveways. This technique gives them extra room for the car, but does nothing for the structural integrity of the carport. Both uplift wind forces and downburst from storms will collapse these types of carport.
