Pinellas County Tornado and Downburst Wind Event

March 31, 2011

STORM DAMAGE ASSESSMENT

**A study of the installation of manufactured/mobile homes
and the effects of storm damage.**

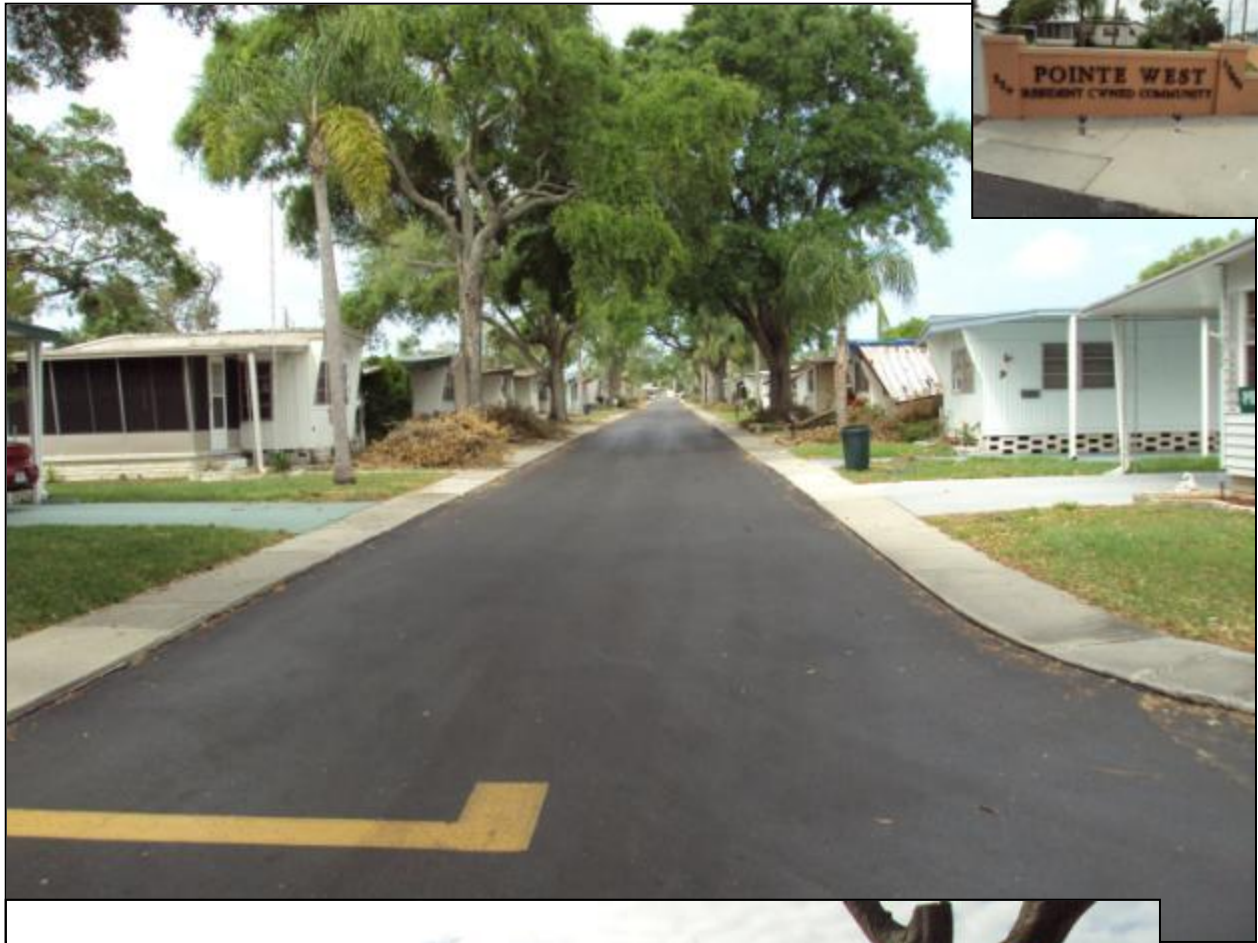
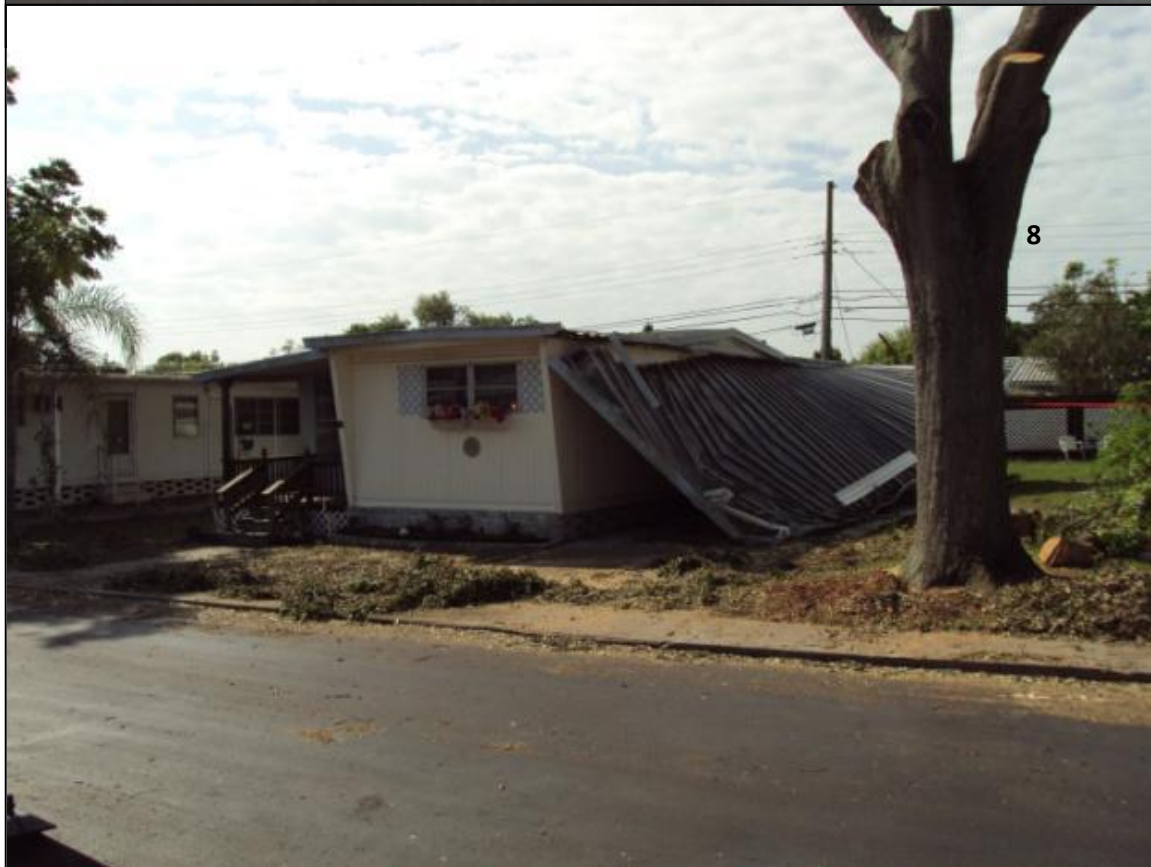
Old style carports will continue to be a problem during storms. The 1 ½ inch aluminum columns will not keep the carport in place during high winds.

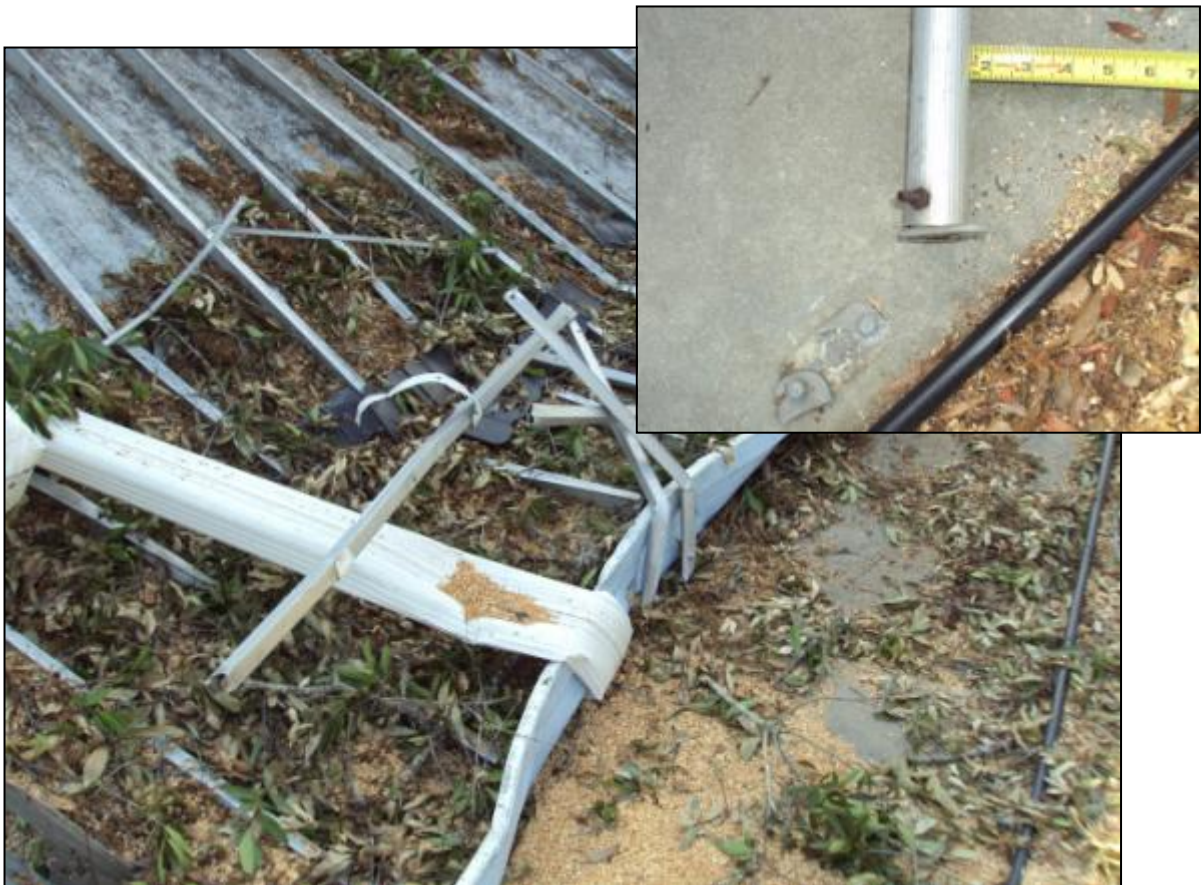
Some homeowners are modifying their column supports on their driveways. This technique gives them extra room for the car, but does nothing for the structural integrity of the carport. Both uplift wind forces and downburst from storms will collapse these types of carport.
